Wamplers Lake 2022 Aquatic Vegetation, Water Quality, & 2023 Management Recommendations Report

October, 2022

© Restorative Lake Sciences
18406 West Spring Lake Road
Spring Lake, Michigan 49456
Website: <http://www.restorativelakesciences.com>

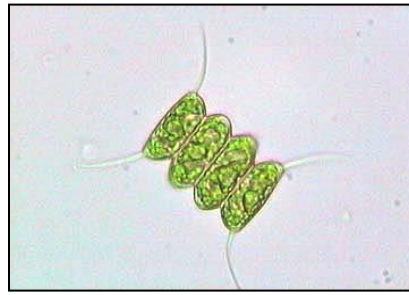
Figure 1. A Green Alga

The algal genera were determined from composite water samples collected over the deep basin of Wamplers Lake in 2022 were analyzed with a compound bright field microscope. The genera present included the Chlorophyta (green algae; Figure 1): *Chlorella* sp., *Rhizoclonium* sp., and *Cladophora* sp., *Scenedesmus* sp., and *Mougeotia* sp.; The Cyanophyta (blue-green algae; Figure 2): *Oscillatoria* sp.; The Bascillariophyta (diatoms; Figure 3): *Synedra* sp., *Cymbella* sp., *Navicula* sp., and *Rhoicosphenia* sp. The aforementioned species indicate a diverse algal flora and represent a good diversity of alga with an abundance of diatoms that are indicative of great water quality. Photos of the general algae types are shown below.

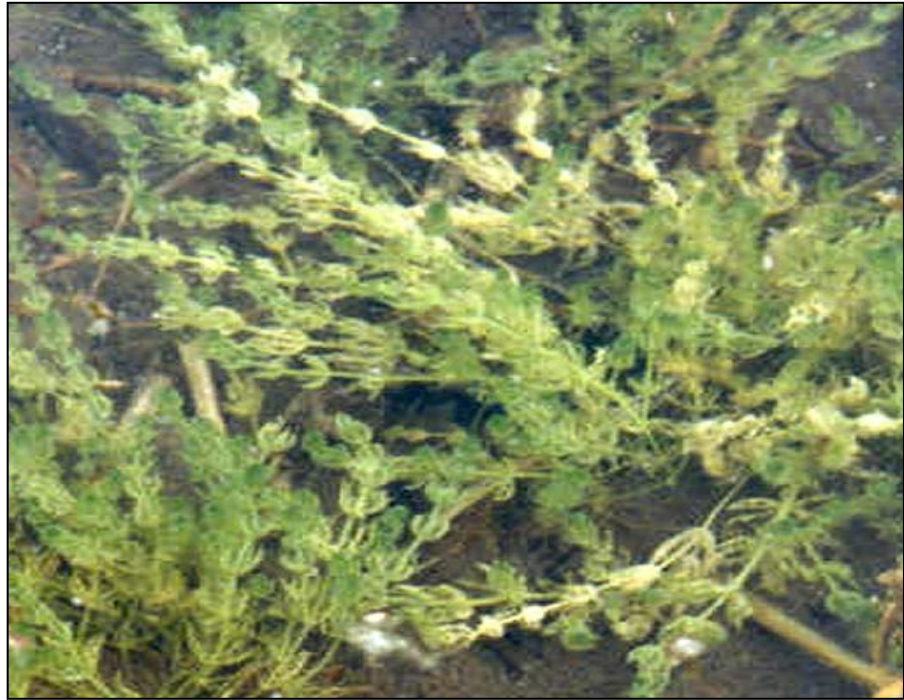
Figure 4. Chara

Among the most dominant native aquatic plants was the macro alga, Chara (Figure 4) which lies close to the lake bottom and serves as excellent fish spawning habitat. In addition, Chara also helps to keep the small sediment particles from being suspended in the water column. The plant has a distinctive musky odor which smells skunk-like. Also abundant was the Illinois Pondweed (Figure 5), a native perennial herb with narrow leaves and divided, whorled flower spikes that remain completely submerged throughout the growing season.

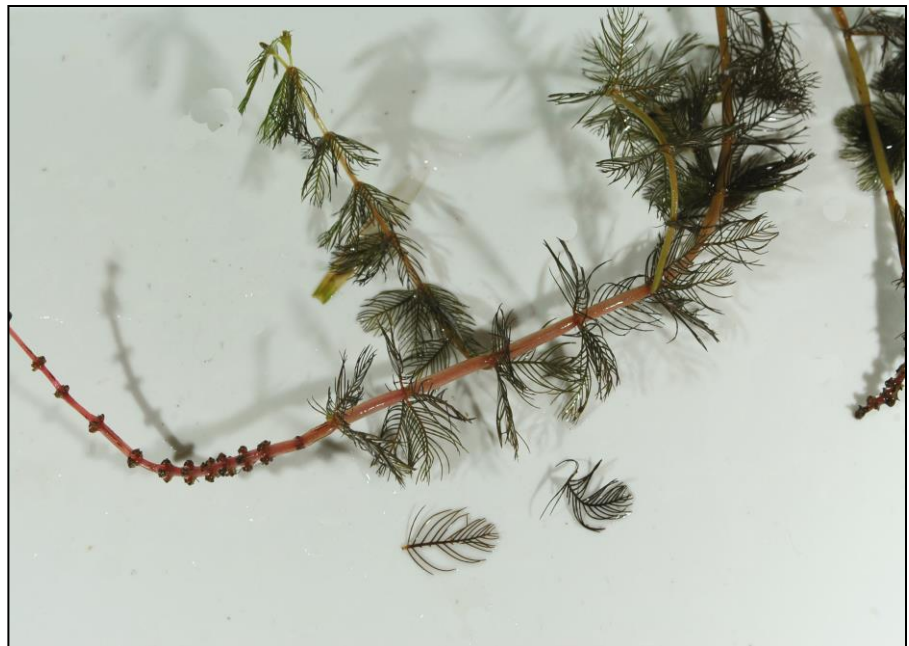
Figure 6. Eurasian Watermilfoil

The amount of Eurasian Watermilfoil (Figure 6) present in Wamplers Lake varies each year and is dependent upon climatic conditions, especially runoff-associated nutrients. This year we saw above average temperatures and precipitation and many lakes experienced nuisance milfoil and algal outbreaks. The May 30, 2022 survey revealed that approximately 17.9 acres of hybrid milfoil was found throughout the entire lake. On June 22, 2022, the milfoil was treated with diquat. RLS was present to oversee the treatments conducted by Aqua-Weed Control, Inc. On August 1, 2022, a thorough treatment of the canals was conducted. A late summer whole-lake aquatic plant survey revealed that the treatment was very successful but a large area of EWM was noted in the south area of the lake and will be treated in spring 2023 if it survives the winter. An additional 19.3 acres of very dense Curly-leaf Pondweed (Figure 7) was also treated with diquat at the same time. Figure 8 shows a late-season outbreak of milfoil.

Due to the relative scarcity of native aquatic vegetation in Wamplers Lake, the treatment of these species with aquatic herbicides is not recommended (one exception is the overgrowth of nuisance weeds in the canals). The plan for 2023 includes the use of higher doses of systemic aquatic herbicides due to the genetically determined strains of hybrid milfoil that require such doses for effective treatment. A new systemic herbicide ProcellaCOR® may also be used and has demonstrated good efficacy. It is costly but has sustained control. The nuisance growth in the canals would respond well to flumioxazin at 200 ppb if needed or with a combination of diquat and hydrothol. Curly-leaf Pondweed will respond well to Aquathol-K® at 1-2 gallons per acre or with diquat at the same doses. Starry Stonewort will respond well to a mixture of Clipper® at 200 ppb and chelated copper.

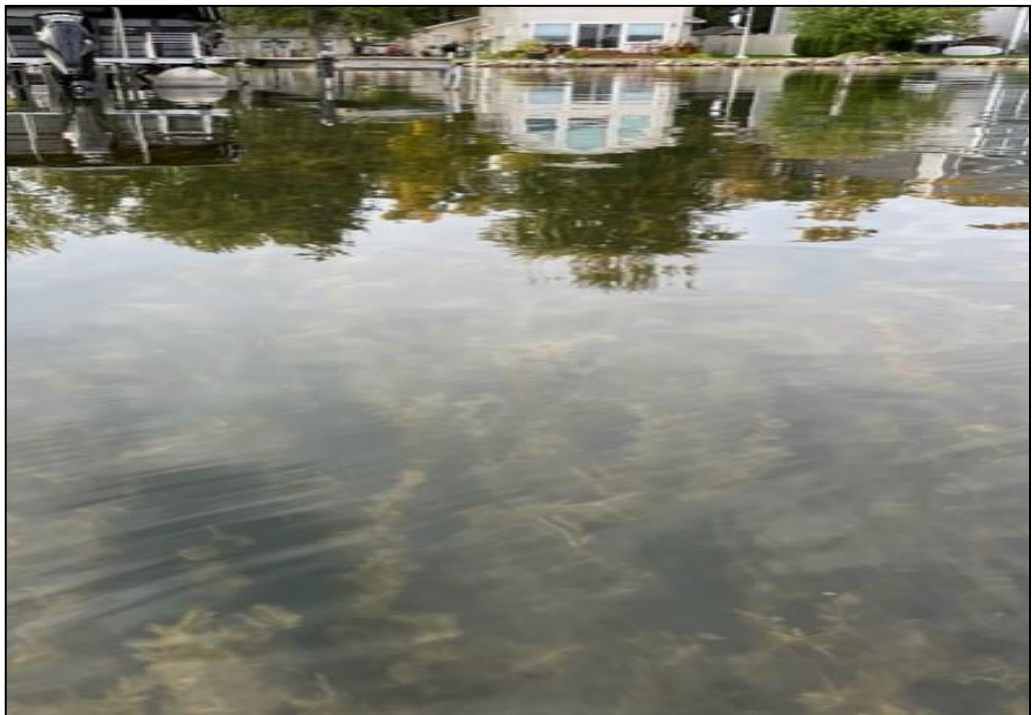
Figure 8. Late season EWM growth in Wamplers Lake (August, 2022)

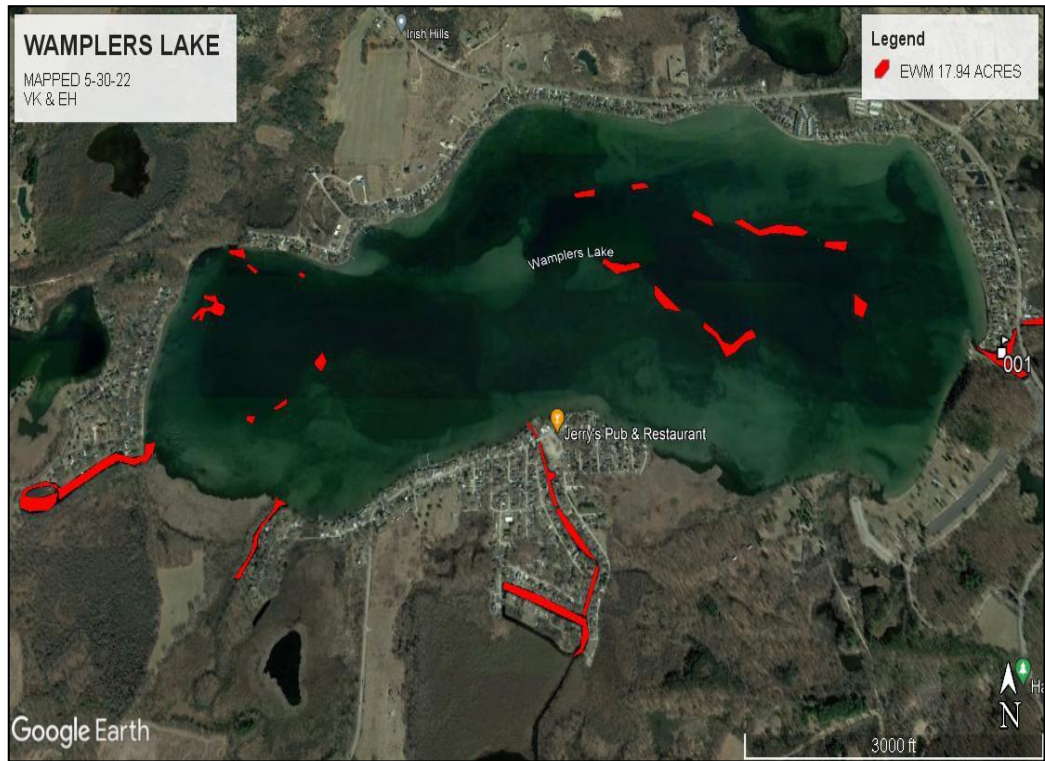
The Treatment maps for milfoil for each of these invasive species are shown in the maps below (Figures 9-10).

Figure 9. Eurasian Watermilfoil distribution in Wamplers Lake (May 30, 2022).
